12-Inch Unit A Rancho Santa Fe Road Pipeline Inspection and Condition Assessment Report

Olivenhain Municipal Water District
Carlsbad, CA

July 13, 2020

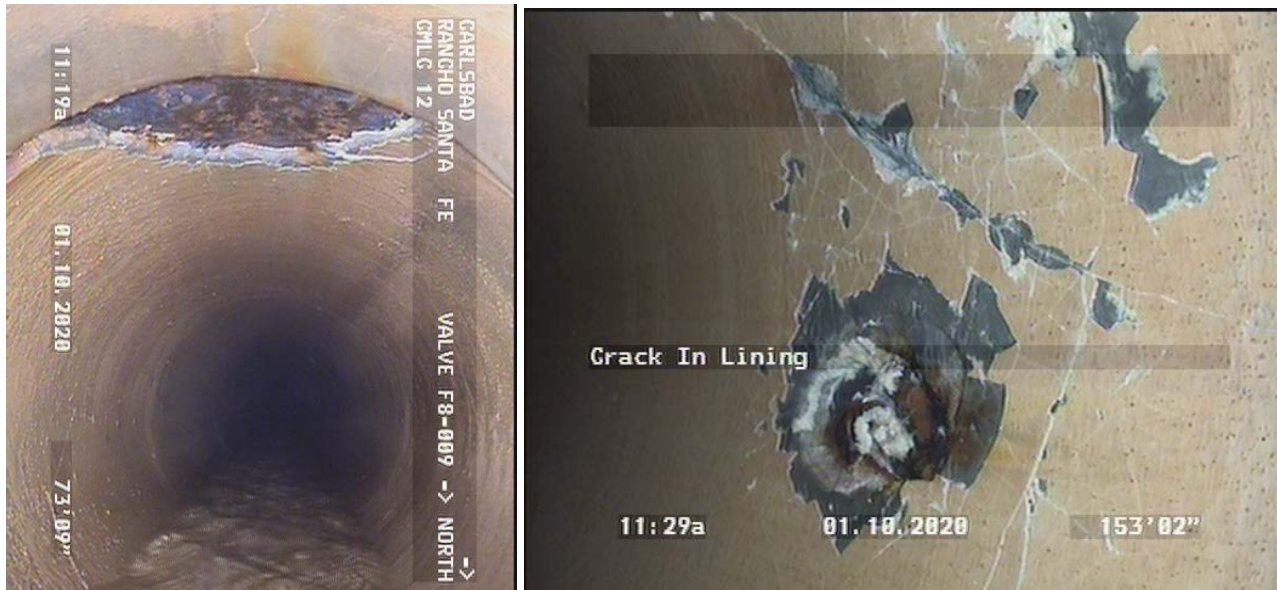
Figure ES 1-3. Group 2 Video Inspection Defect Examples With Significant Bare Steel and Rust

There are several locations where PICA's RFT identified significant wall loss or the video revealed bare steel with significant rust. These defects should be repaired or addressed in the near-term. These types of defects could be grouped together and assessed and repaired through a future project. There may be more Group 2 defects located along the portion of the pipeline that was not assessed with video inspection.

There are a total of 16 Group 2 defects identified including 13 identified by PICA and 3 identified through video inspection. A summary of the Group 2 defects includes the following:

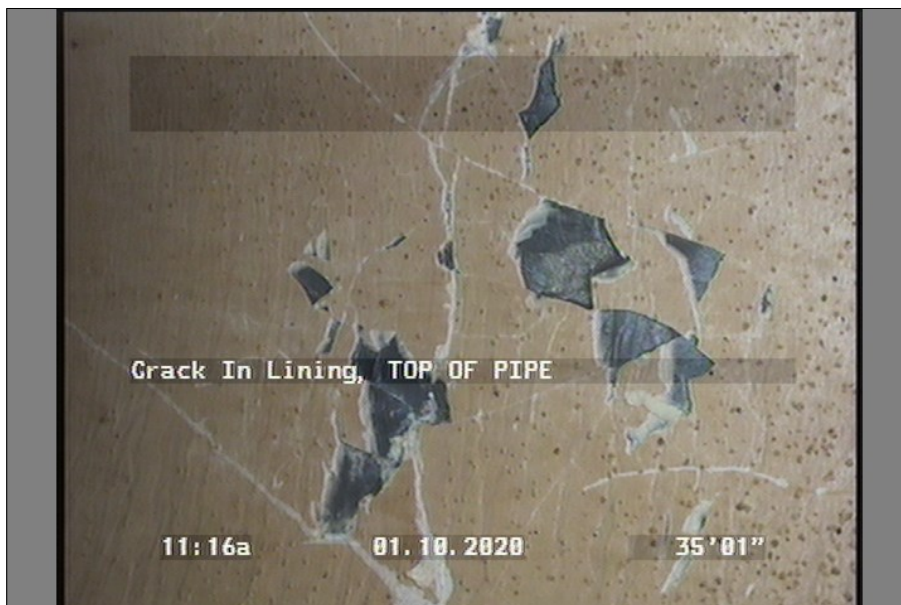
Photo: VALVE F8-009-NORTH-D-35.0567-111451.JPG
Crack In Lining

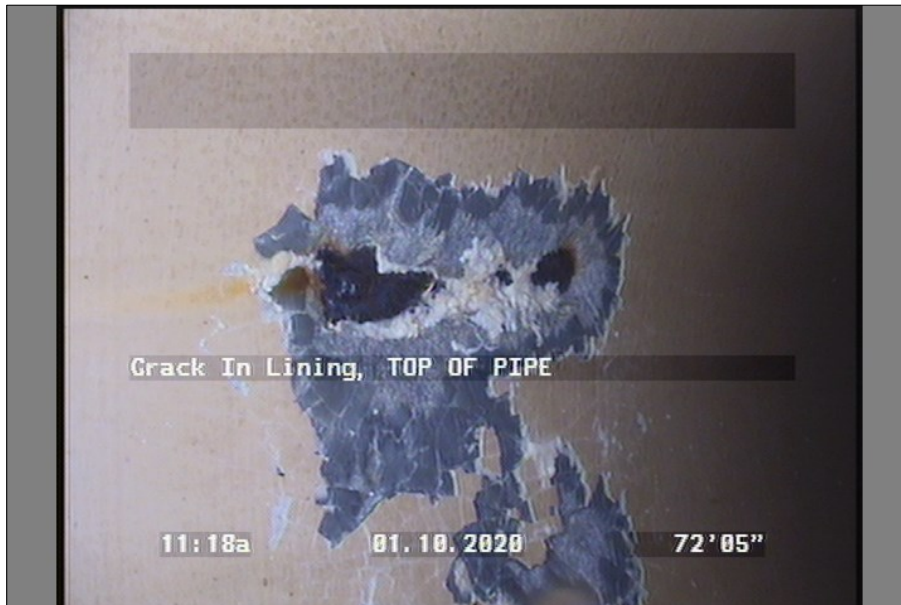
Photo: VALVE F8-009-NORTH-D-72.3885-111709.JPG
Crack In Lining

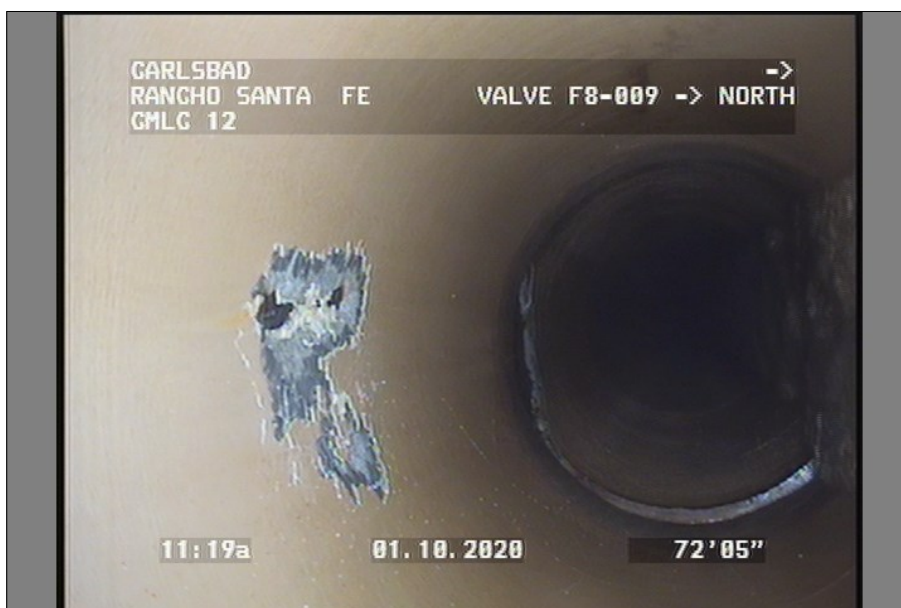
Photo: VALVE F8-009-NORTH-D-72.3885-111720.JPG
Crack In Lining

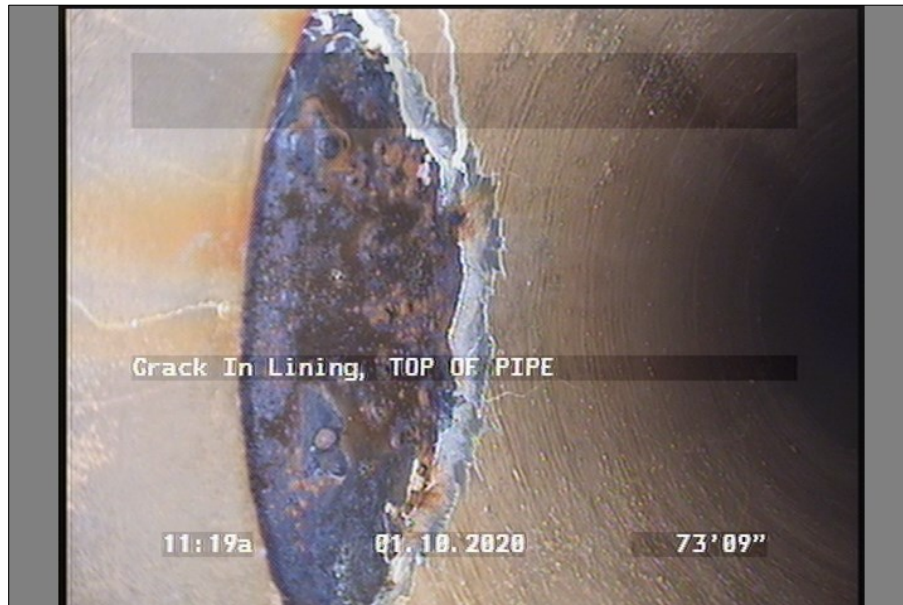
Photo: VALVE F8-009-NORTH-D-73.7328-111808.JPG
 Crack In Lining

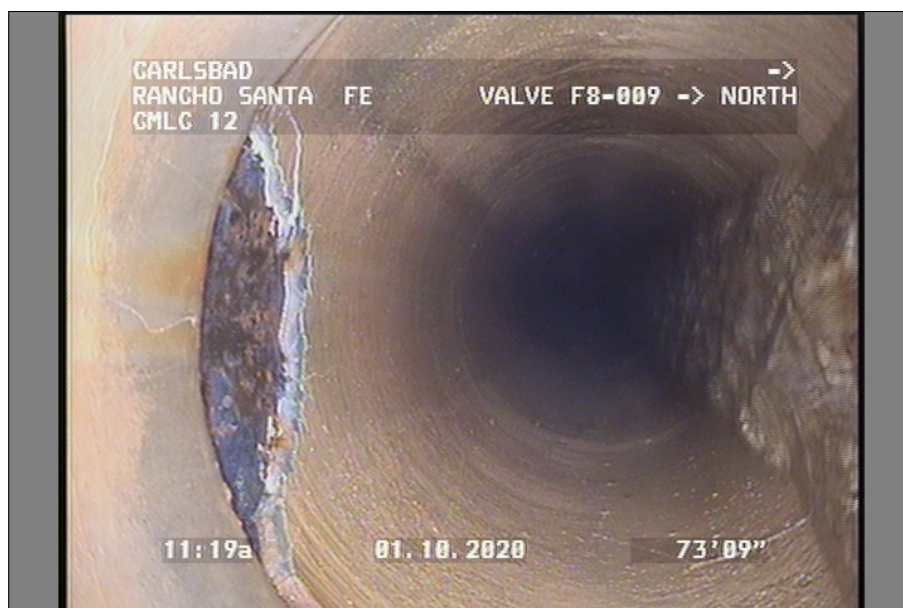
Photo: VALVE F8-009-NORTH-D-73.7328-111816.JPG
 Crack In Lining

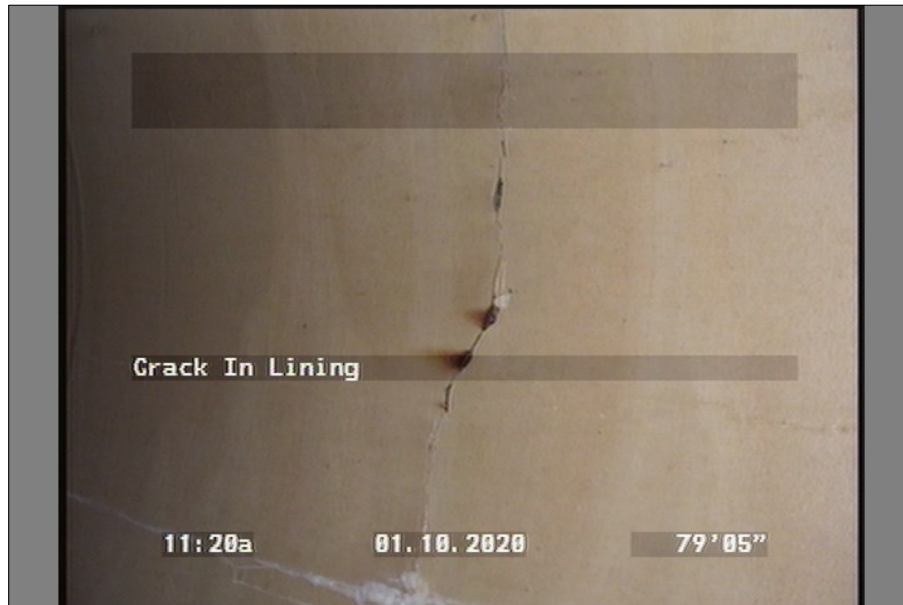
Photo: VALVE F8-009-NORTH-D-79.4205-111918.JPG
 Crack In Lining

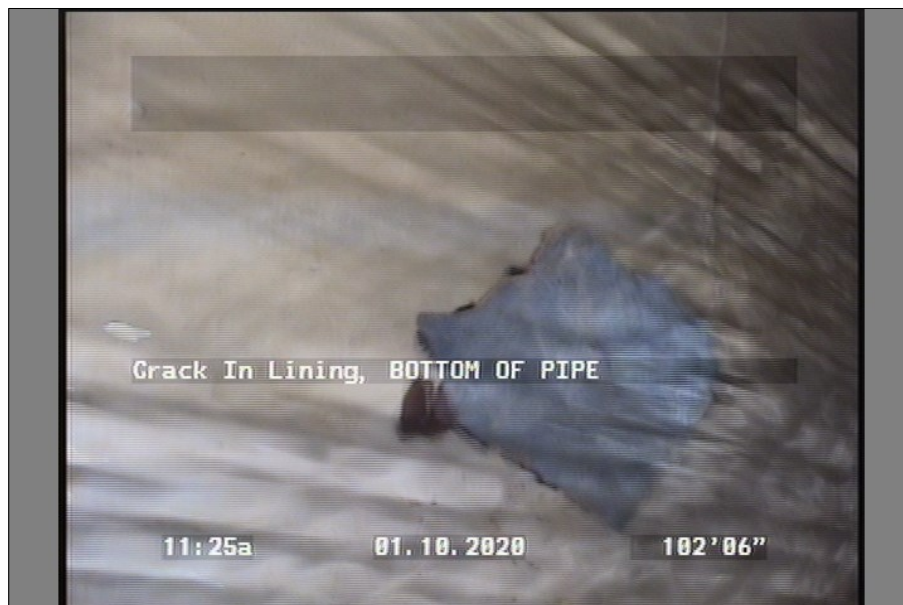
Photo: VALVE F8-009-NORTH-D-102.4814-112341.JPG
Crack In Lining

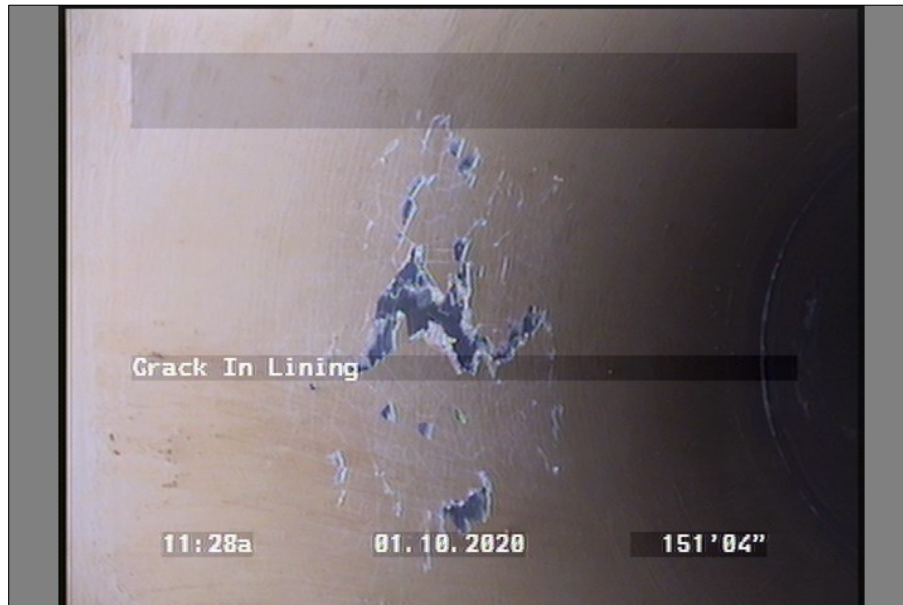
Photo: VALVE F8-009-NORTH-D-151.2919-112637.JPG
 Crack In Lining

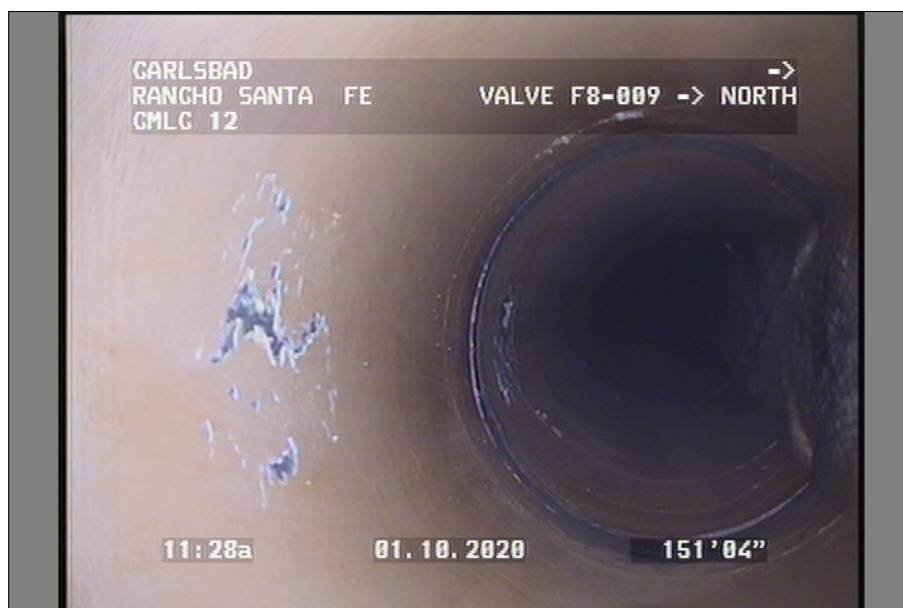
Photo: VALVE F8-009-NORTH-D-151.2919-112648.JPG
 Crack In Lining

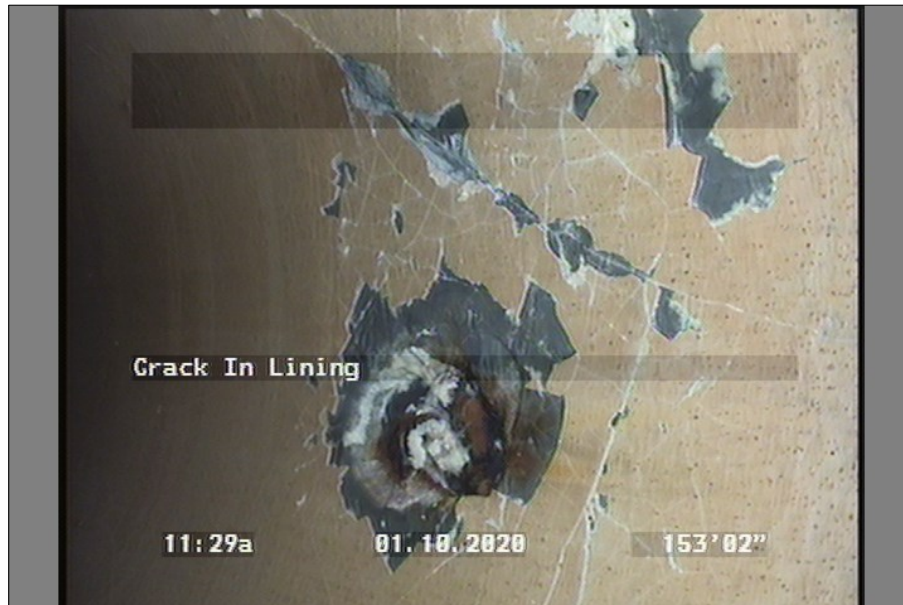
Photo: VALVE F8-009-NORTH-D-153.1533-112729.JPG
 Crack In Lining

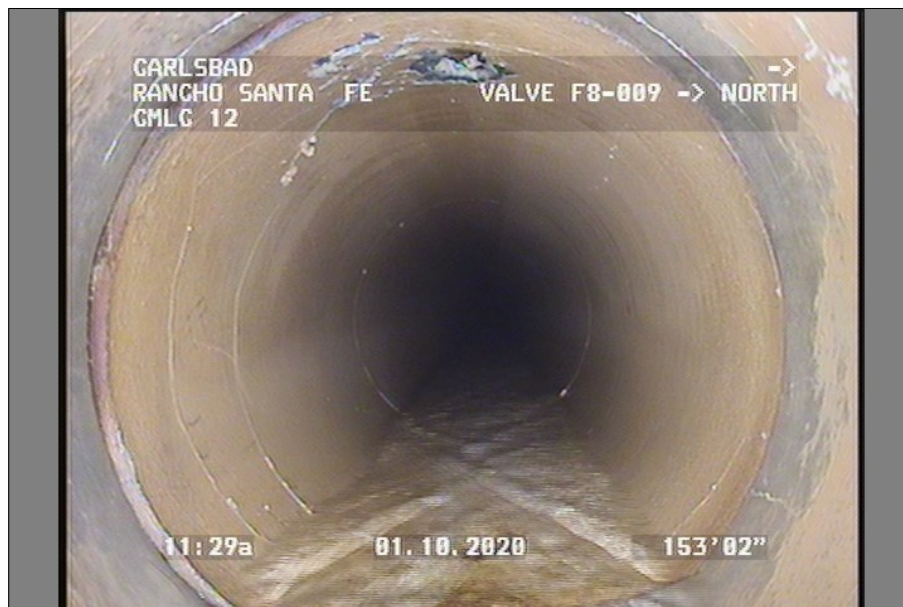
Photo: VALVE F8-009-NORTH-D-153.1533-112744.JPG
 Crack In Lining

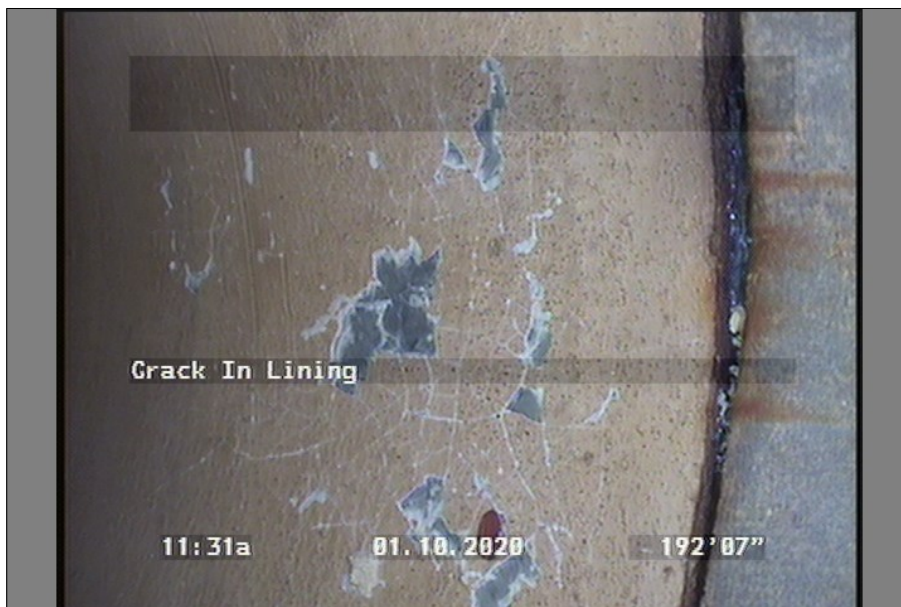
Photo: VALVE F8-009-NORTH-D-192.5533-113009.JPG

Crack In Lining

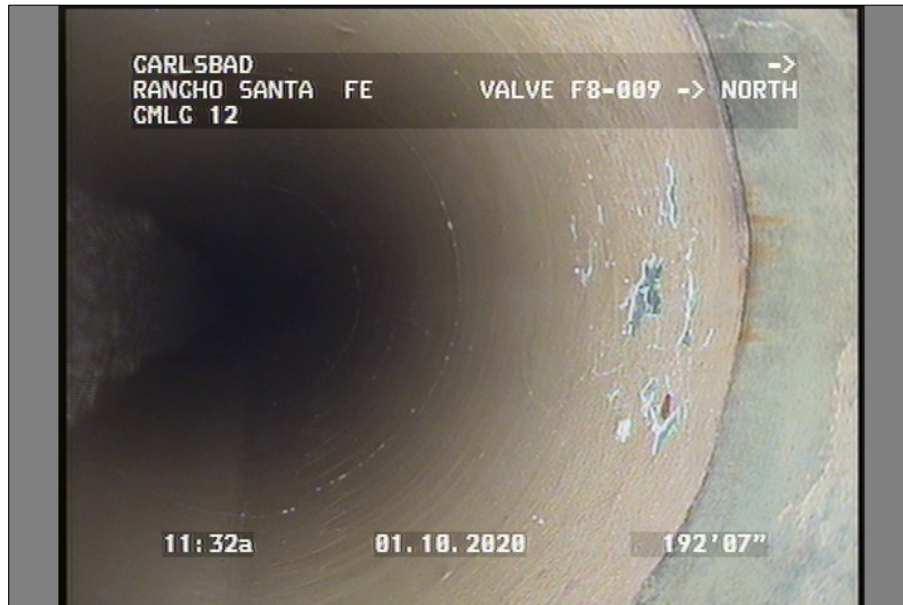
Photo: VALVE F8-009-NORTH-D-192.5533-113020.JPG
 Crack In Lining

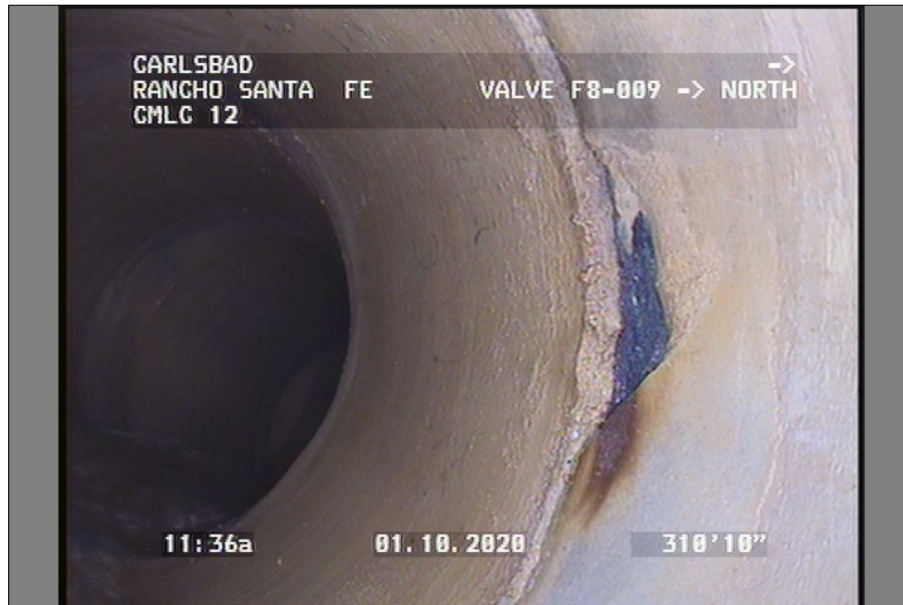
Photo: VALVE F8-009-NORTH-D-310.8567-113430.JPG
 Crack In Lining
