**CAPITAL IMPROVEMENT PLAN
FOR
4S RANCH AND RANCHO CIELO
WASTEWATER SYSTEMS**

Municipal Water District
1966 Olivenhain Road
Encinitas, CA 92024
Contact: George Briest, PE

DUDEK

SEPTEMBER 2015

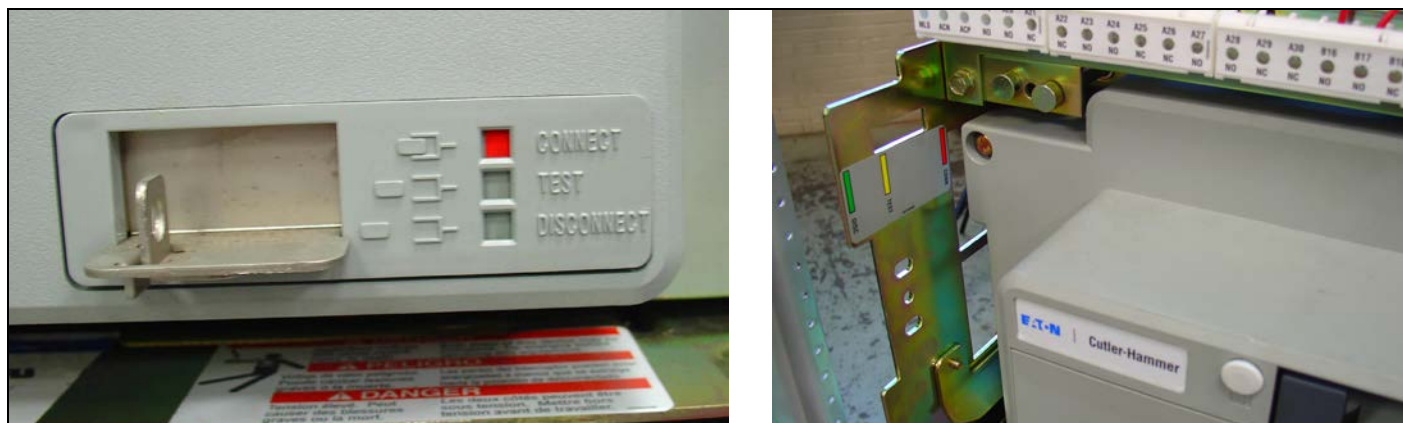
Figure 30. Switching Device in the CONNECT Position.
