**CAPITAL IMPROVEMENT PLAN
FOR
4S RANCH AND RANCHO CIELO
WASTEWATER SYSTEMS**

Municipal Water District
1966 Olivenhain Road
Encinitas, CA 92024
Contact: George Briest, PE

DUDEK

SEPTEMBER 2015

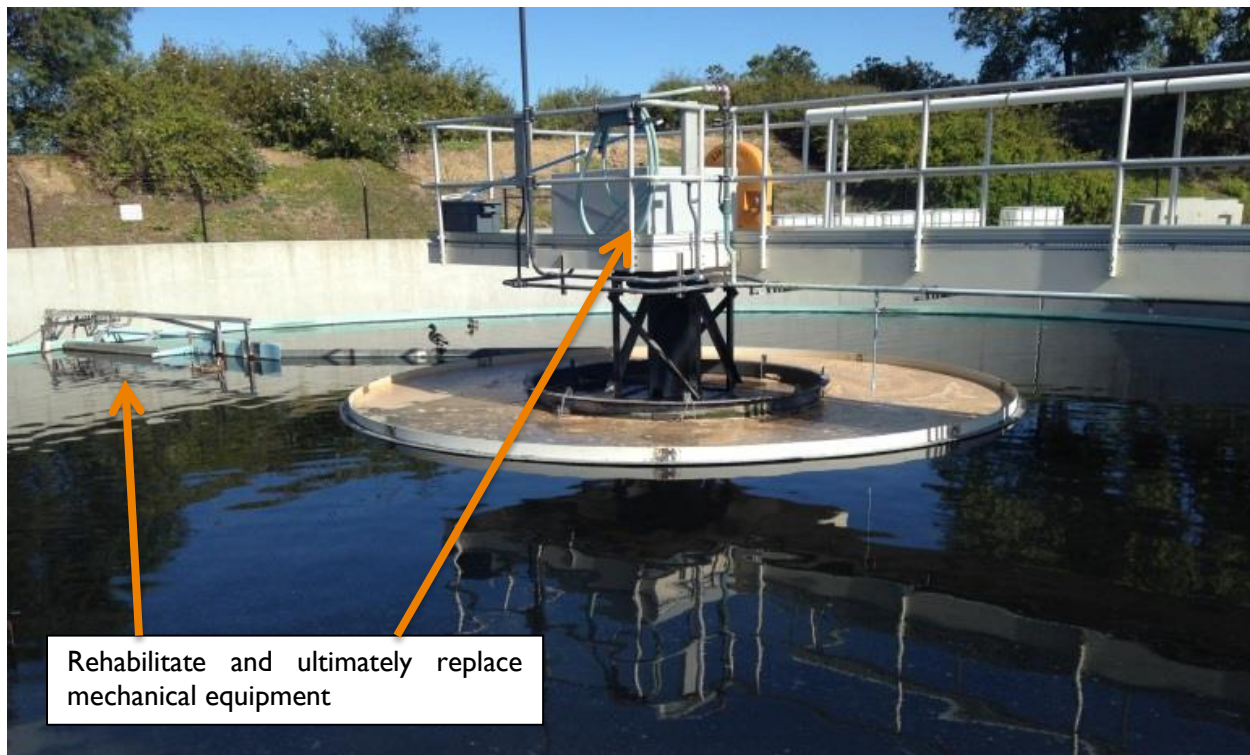
Figure 2-8. Secondary Clarifiers Improvements Projects

Project No:	WRF - 3.0		
Project Name:	Replace Plant B Secondary Clarifier Equipment		
Description:	Replace the existing secondary clarifier mechanical equipment including skimmer, scraper, sludge rake, and drive on both Plant B secondary clarifiers.		
Priority:	35		
Location/Facility:	4S Ranch WRF		
Project Type:		Origin(s) of Project:	
Rehab/Replacement	<input checked="" type="checkbox"/>	Predicted Useful Life Expiration	<input checked="" type="checkbox"/>
Facility/Equip Upgrade	<input type="checkbox"/>	Condition Assessment	<input type="checkbox"/>
Engineering Study	<input type="checkbox"/>	Operations Assessment	<input type="checkbox"/>
Expansion	<input type="checkbox"/>	Failure Modes & Consequences	<input type="checkbox"/>
Project Cost:			
Capital Costs:			
General		\$	30,000
Civil & Mechanical		\$	106,280
Structural		\$	-
Electrical & Controls		\$	50,000
Equipment		\$	486,700
Capital Cost Subtotal:		\$	672,980

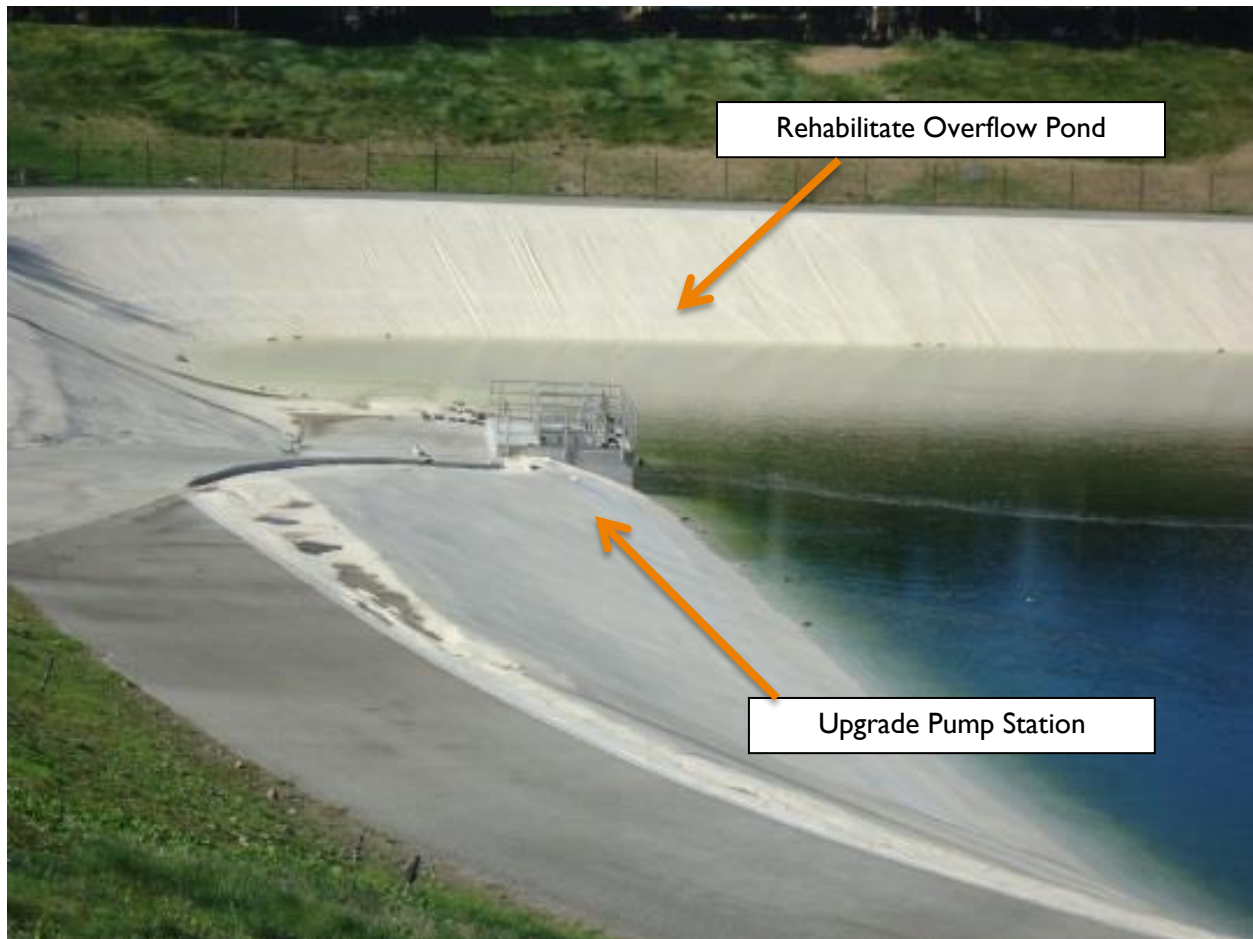
Figure 2-15. Recycled Water Pump Station Improvements Projects

Project No:	WRF - 11.2		
Project Name:	Overflow Pond Upgrades		
Description:	<p>Overflow Pond was built in c.2002.</p> <p>Replace the Overflow Pond liner. Construct new concrete access ramp. Miscellaneous facility improvements.</p> <p>Project costs defined in the District's FY 14-15 Capital Spending Plan with expenditures planned to begin in FY 15-16.</p>		
Priority:	95		
Location/Facility:	4S Ranch WRF		
Project Type:		Origin(s) of Project:	
Rehab/Replacement	<input checked="" type="checkbox"/>	Predicted Useful Life Expiration	<input checked="" type="checkbox"/>
Facility/Equip Upgrade	<input checked="" type="checkbox"/>	Condition Assessment	<input type="checkbox"/>
Engineering Study	<input type="checkbox"/>	Operations Assessment	<input checked="" type="checkbox"/>
Expansion	<input type="checkbox"/>	Failure Modes & Consequences	<input type="checkbox"/>
Project Cost:			
Capital Costs:			
General	\$		-
