# Geotechnical Evaluation

Neighborhood No. 1 Sewer Pump Station Replacement  
16106 4S Ranch Parkway  
San Diego, California

February 21, 2018 | Project No. 108505001

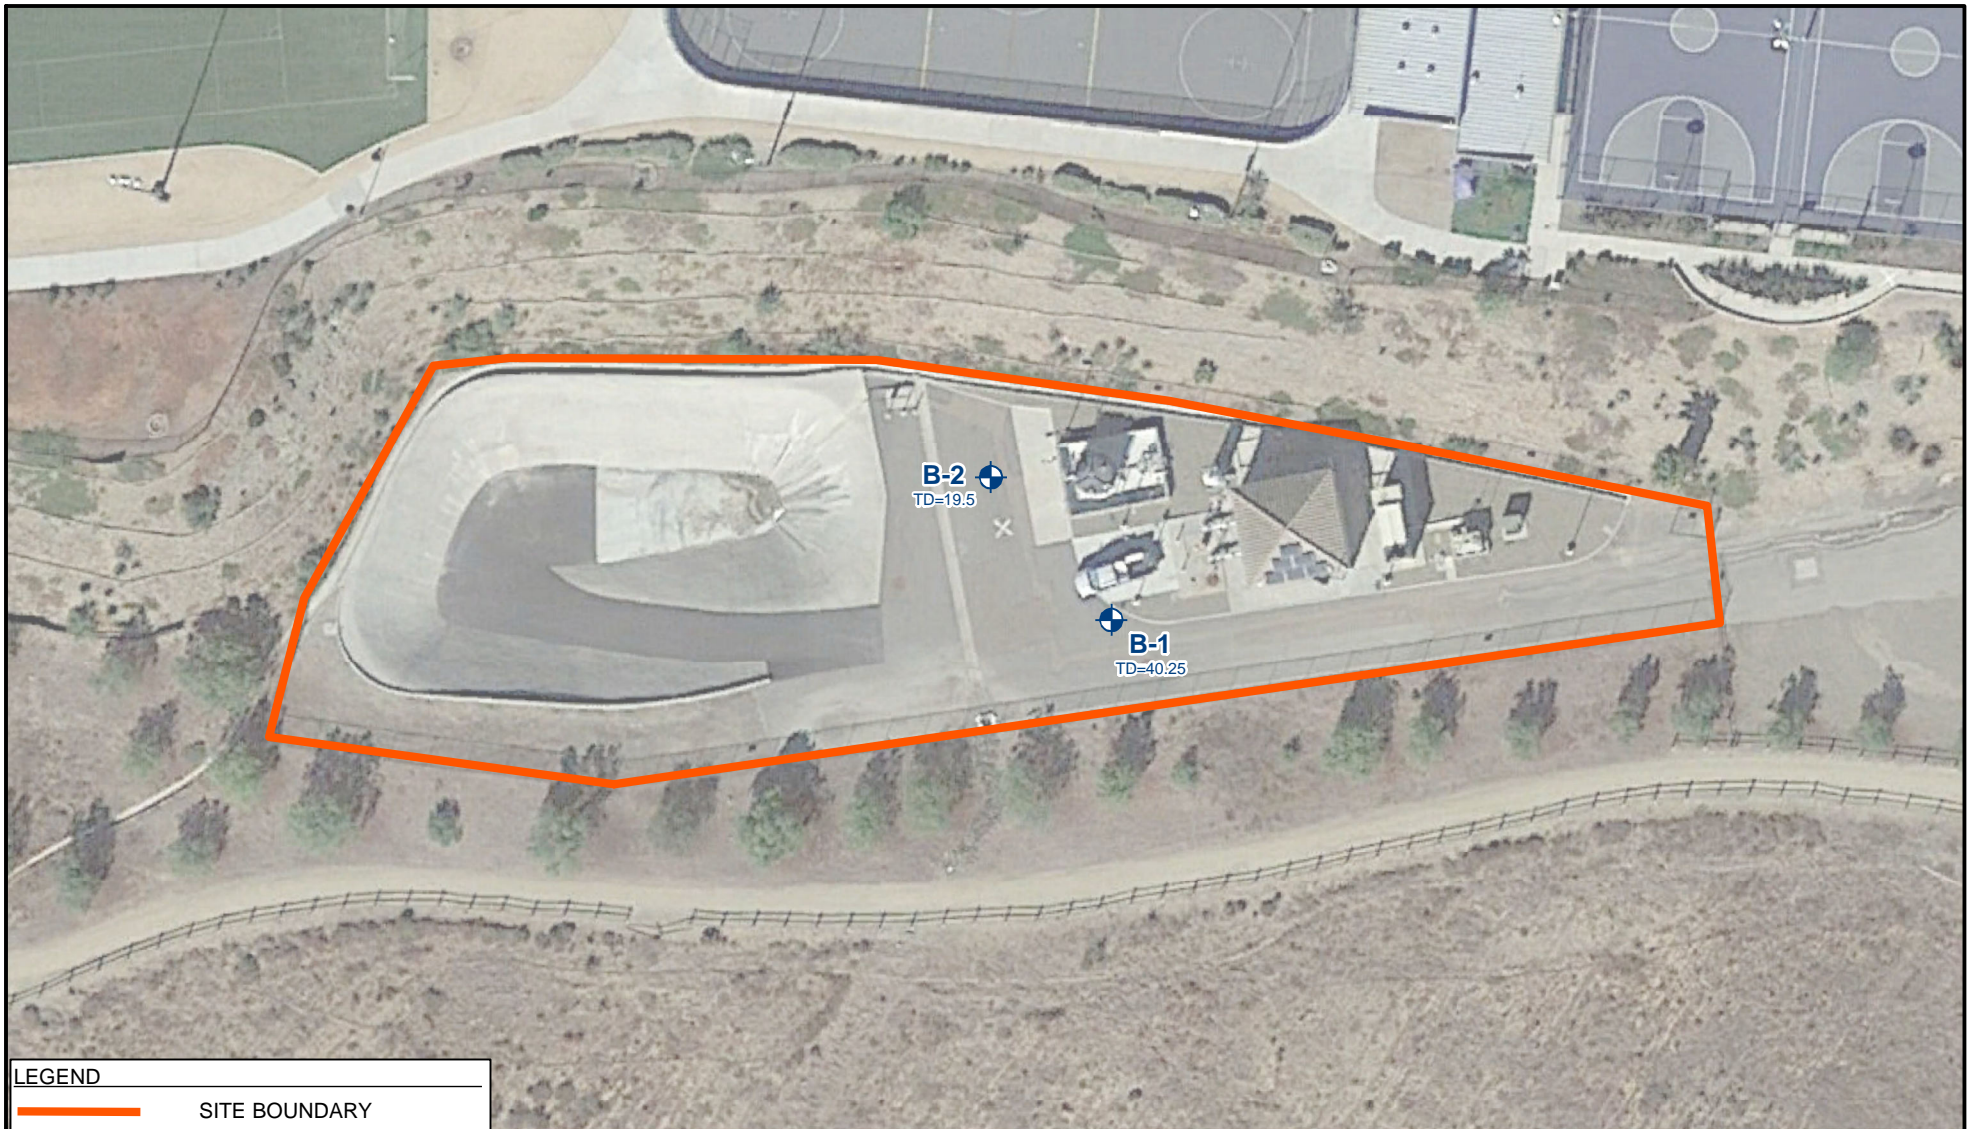
LEGEND	
	SITE BOUNDARY
<b>B-2</b> TD=19.5	BORING TD=TOTAL DEPTH IN FEET

Our subsurface exploration was performed on January 2, 2018 and consisted of the drilling, logging, and sampling of two small-diameter borings (B-1 and B-2). Prior to commencing the subsurface exploration, USA was notified to mark out the existing utilities. The purpose of the borings was to evaluate subsurface conditions and to collect samples for geotechnical laboratory testing.

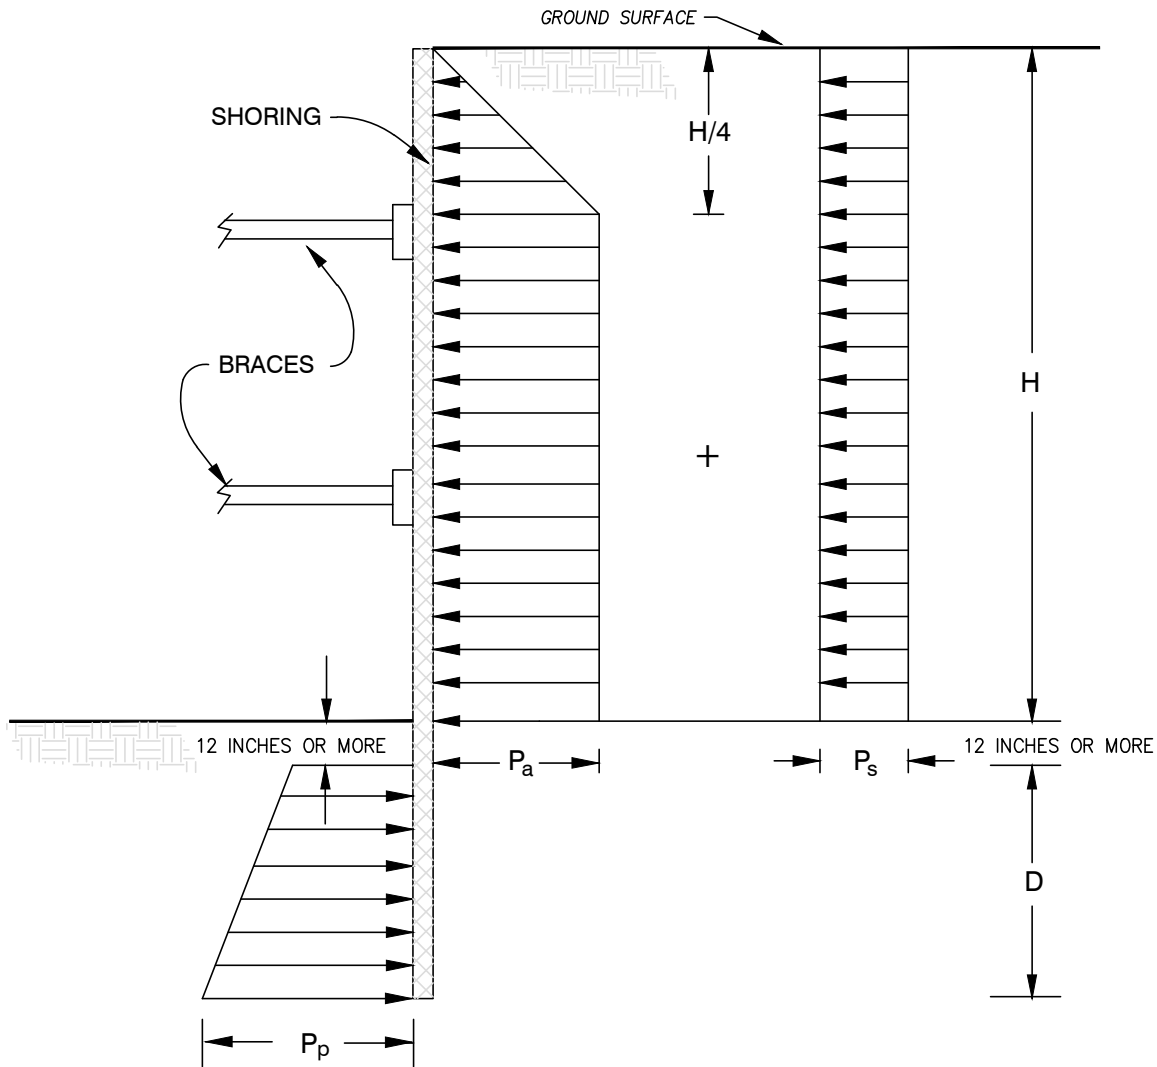
1. APPARENT LATERAL EARTH PRESSURE,  $P_a$   
 $P_a = 45 H$  psf
2. CONSTRUCTION TRAFFIC INDUCED SURCHARGE PRESSURE,  $P_s$   
 $P_s = 120$  psf
3. PASSIVE LATERAL EARTH PRESSURE,  $P_p$   
 $P_p = 1,950$  psf
4. ASSUMES GROUNDWATER IS NOT PRESENT
5. SURCHARGES FROM EXCAVATED SOIL OR CONSTRUCTION MATERIALS ARE NOT INCLUDED
6. H AND D ARE IN FEET

**LATERAL EARTH PRESSURES FOR BRACED EXCAVATION  
(SOFT TO FIRM CLAY)**

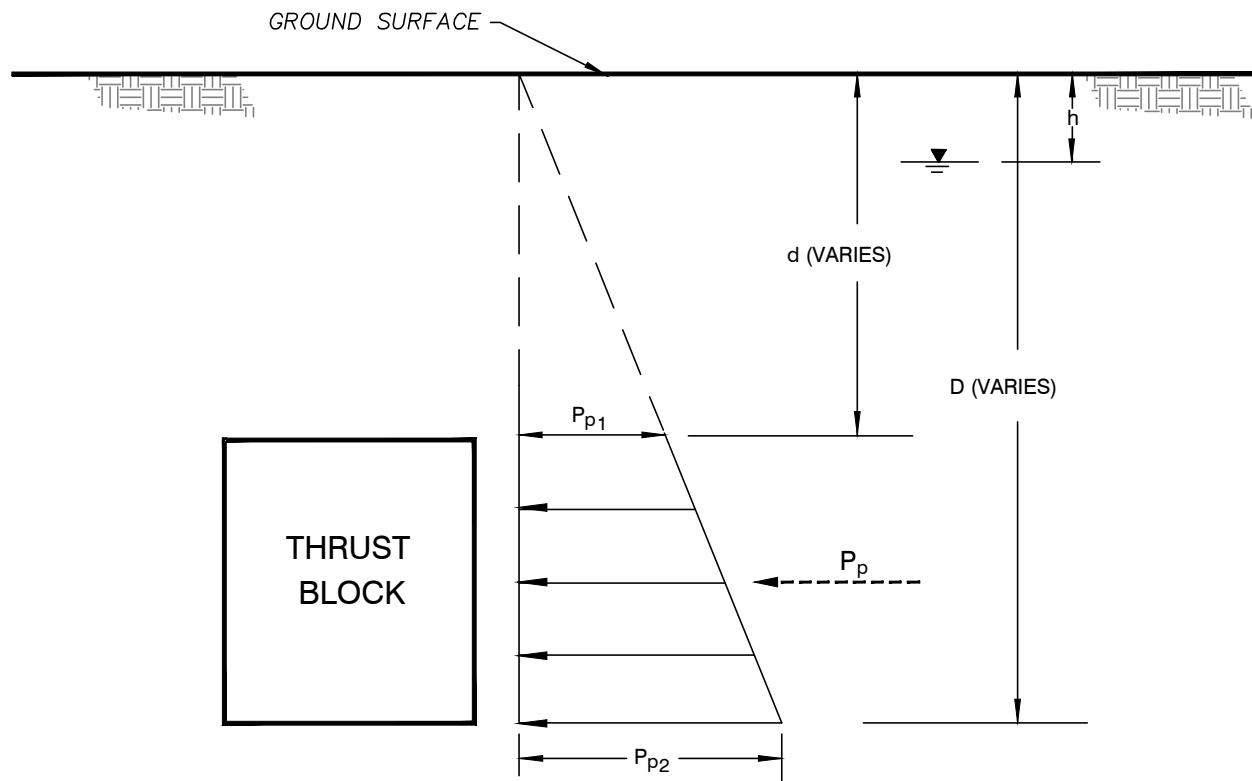
1. GROUNDWATER BELOW BLOCK

THRUST BLOCK LATERAL EARTH PRESSURE DIAGRAM

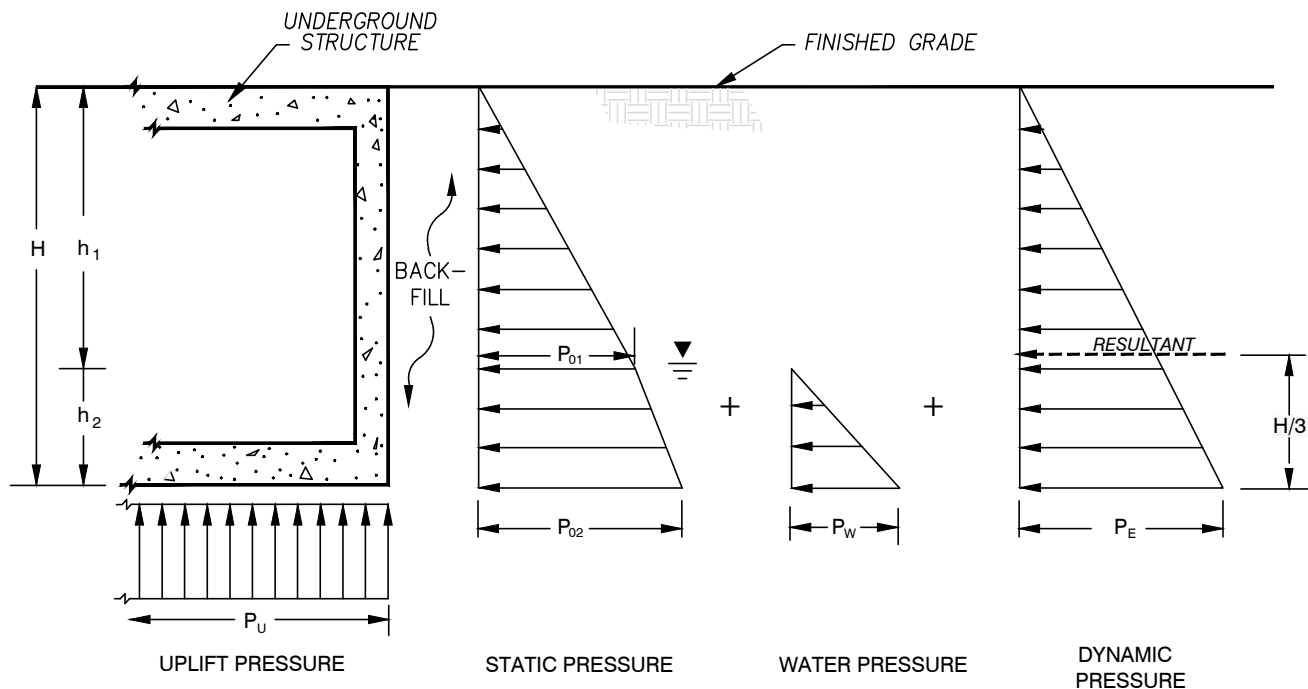
1. APPARENT LATERAL EARTH PRESSURES,  $P_{01}$  AND  $P_{02}$   
 $P_{01} = 60 h_1$  psf  
 $P_{02} = 60 h_1 + 29 h_2$  psf
2. WATER PRESSURE,  $P_w$   
 $P_w = 62.4 h_2$  psf
3. DYNAMIC LATERAL EARTH PRESSURE,  $P_E$ , IS BASED ON A PEAK GROUND ACCELERATION, OF 0.42 g  
 $P_E = 20 H$  psf
4.  $P_E$  IS CALCULATED IN ACCORDANCE WITH THE RECOMMENDATIONS OF MONONOBÉ AND MATSUO (1929), AND ATIK AND SITAR (2010).
5. UPLIFT PRESSURE,  $P_u$   
 $P_u = 62.4 h_2$  psf
6. SURCHARGE PRESSURES CAUSED BY VEHICLES OR NEARBY STRUCTURES ARE NOT INCLUDED
7.  $H$ ,  $h_1$  AND  $h_2$  ARE IN FEET
8.

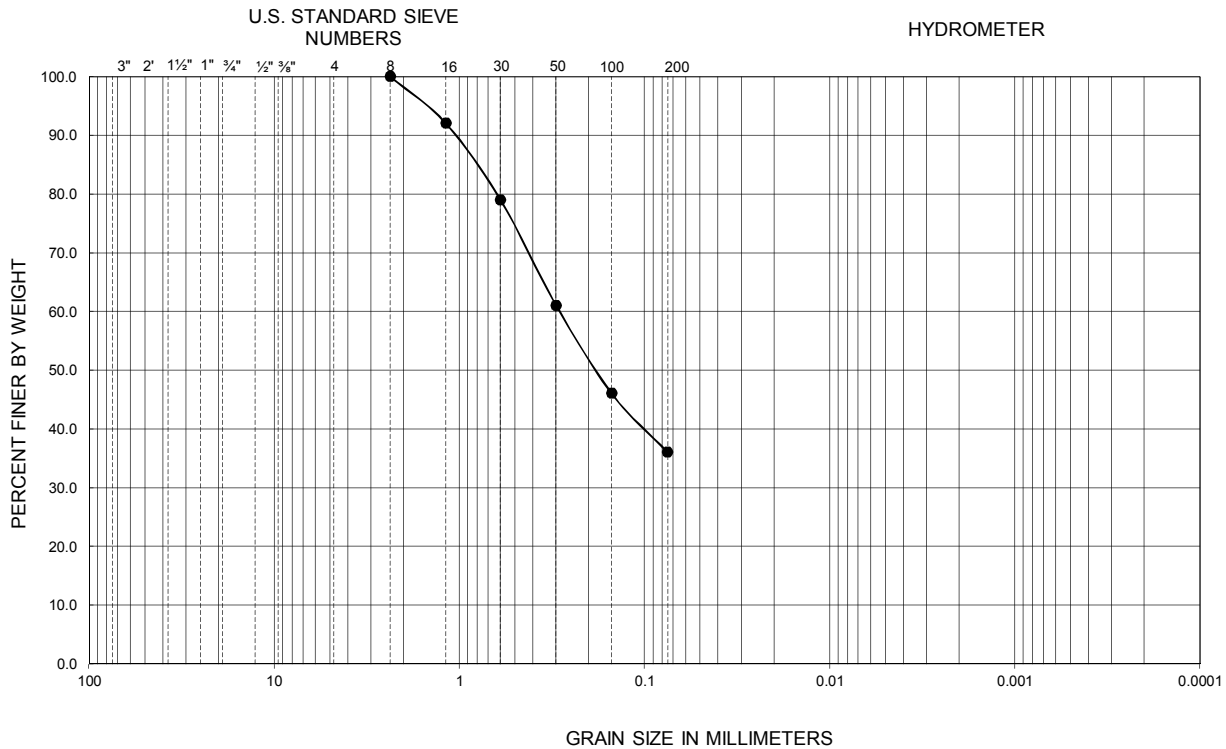
FIGURE B-1

Symbol	Sample Location	Depth (ft)	Liquid Limit	Plastic Limit	Plasticity Index	D <sub>10</sub>	D <sub>30</sub>	D <sub>60</sub>	C <sub>u</sub>	C <sub>c</sub>	Passing No. 200 (percent)	USCS
●	B-1	25.0-26.5	--	--	--	--	--	--	--	--	36	SC

PERFORMED IN GENERAL ACCORDANCE WITH ASTM D 422

Geotechnical laboratory testing of representative soil samples included tests to evaluate in-situ moisture and density, sieve (gradation) analysis, shear strength, expansion index (EI), and soil corrosivity. The results of the in-situ dry density and moisture content test is presented on the boring log in Appendix A. Descriptions of the geotechnical laboratory test methods and the results of the other geotechnical laboratory tests performed are presented in Appendix B.

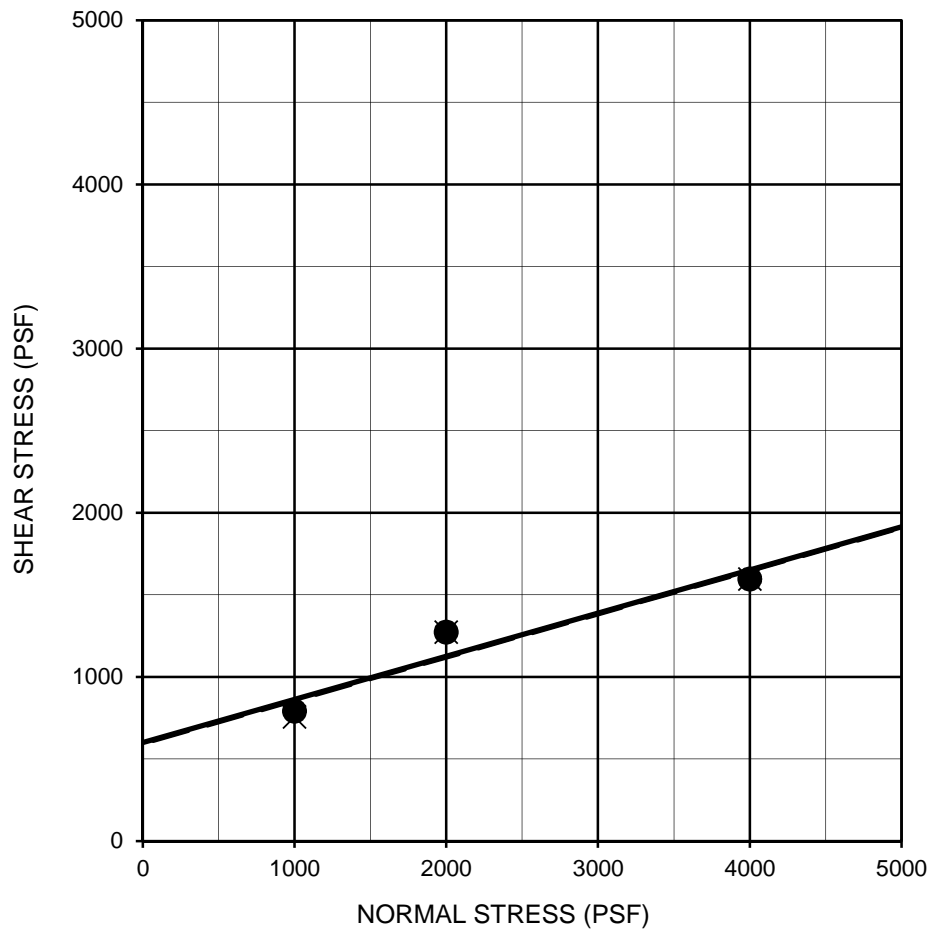
Description	Symbol	Sample Location	Depth (ft)	Shear Strength	Cohesion (psf)	Friction Angle (degrees)	Soil Type
Sandy CLAY	—●—	B-1	5.0-6.5	Peak	600	15	CL
Sandy CLAY	- - X - -	B-1	5.0-6.5	Ultimate	590	15	CL

PERFORMED IN GENERAL ACCORDANCE WITH ASTM D 3080
